Mercedes-Benz

report date: 2024-03-29

Make	MERCEDES
Model	B-CLASS B150 SE
Colour	Black
Year of manufacture	2007
Top speed	108 mph
0 - 60 mph	13.2 seconds
Gearbox	5 speed Manual

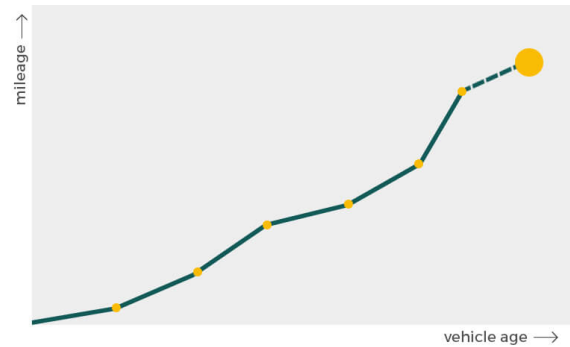
Odometer	In miles
Mileage registrations	19
First mileage registration	2007-03-20
Last registration	2023-03-04
Complete history	<a href="#">See info</a>

Registration #1	2007-03-20	10 mi
Registration #2	2010-03-16	15.697 mi
Registration #3	2011-03-16	20.877 mi
Registration #4	2012-03-15	25.610 mi
Registration #5	2013-03-20	29.505 mi
Registration #6	2014-03-19	32.830 mi
Registration #7	2014-03-20	32.830 mi
Registration #8	2016-01-09	42.278 mi
Registration #9	2016-01-11	42.278 mi
Registration #10	2017-01-11	51.184 mi
Registration #11	2018-01-11	55.184 mi
Registration #12	2018-01-11	55.184 mi
Registration #13	2018-01-11	55.184 mi
Registration #14	2018-01-11	55.184 mi
Registration #15	2018-01-11	55.184 mi
Registration #16	2018-01-11	55.184 mi
Registration #17	2018-01-11	55.184 mi
Registration #18	2018-01-11	55.184 mi
Registration #19	2018-01-11	55.184 mi
