report date: 2024-03-28

Make	VOLKSWAGEN
Model	BEETLE 8V
Colour	Blue
Year of manufacture	2003
Top speed	112 mph
0 - 60 mph	12.9 seconds
Gearbox	6 speed automatic

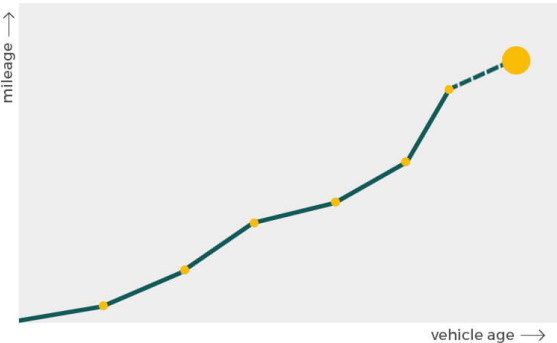
Mileage check

Odometer	In miles
Mileage registrations	24
First mileage registration	2003-06-24
Last registration	2023-03-10
Complete history	See info

Registration #1	2003-06-24	25 mi
Registration #2	2006-06-30	16.735 mi
Registration #3	2007-09-03	25.657 mi
Registration #4	2008-09-24	28.399 mi
Registration #5	2010-08-17	36.210 mi
Registration #6	2011-08-26	47.280 mi
Registration #7	2012-08-14	56.097 mi
Registration #8	2012-08-17	56.097 mi
Registration #9	2013-09-02	63.718 mi
Registration #10	2015-02-09	71.572 mi
Registration #11	2016-03-11	74.985 mi
Registration #12	2016-05-18	75.112 mi
Registration #13	2016-05-18	75.112 mi
Registration #14	2016-05-18	75.112 mi
Registration #15	2016-05-18	75.112 mi
Registration #16	2016-05-18	75.112 mi
Registration #17	2016-05-18	75.112 mi
Registration #18	2016-05-18	75.112 mi
Registration #19	2016-05-18	75.112 mi
Registration #20	2016-05-18	75.112 mi
Registration #21	2016-05-18	75.112 mi
Registration #22	2016-05-18	75.112 mi
Registration #23	2016-05-18	75.112 mi
Registration #24	2016-05-18	75.112 mi
