N719XFJ

report date: 2024-03-28

Make	MAZDA
Model	BONGO
Colour	Black
Year of manufacture	1995
Gearbox	-

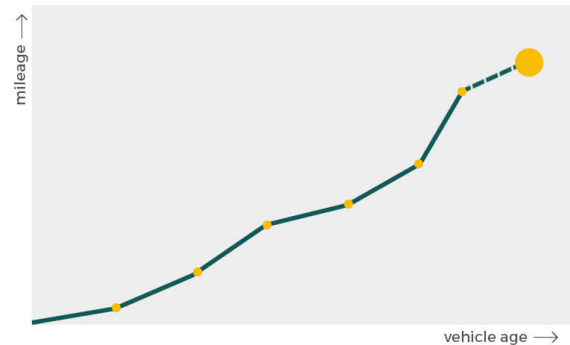
Mileage check

Odometer	In kilometers
Mileage registrations	26
First mileage registration	2004-02-01
Last registration	2020-02-19
Complete history	See info

Registration #1	2004-02-01	17 mi
Registration #2	2006-01-26	77.475 mi
Registration #3	2007-01-17	137.748 mi
Registration #4	2008-01-21	148.646 mi
Registration #5	2009-01-23	100.002 mi
Registration #6	2009-01-23	100.002 mi
Registration #7	2010-01-19	108.531 mi
Registration #8	2011-01-25	114.538 mi
Registration #9	2012-01-20	192.011 mi
Registration #10	2012-01-24	119.344 mi
Registration #11	2013-01-15	124.689 mi
Registration #12	2013-06-14	126.599 mi
Registration #13	2013-06-14	126.599 mi
Registration #14	2013-06-14	126.599 mi
Registration #15	2013-06-14	126.599 mi
Registration #16	2013-06-14	126.599 mi
Registration #17	2013-06-14	126.599 mi
Registration #18	2013-06-14	126.599 mi
Registration #19	2013-06-14	126.599 mi
Registration #20	2013-06-14	126.599 mi
Registration #21	2013-06-14	126.599 mi
Registration #22	2013-06-14	126.599 mi
Registration #23	2013-06-14	126.599 mi
Registration #24	2013-06-14	126.599 mi
Registration #25	2013-06-14	126.599 mi
