General information

Make	VAUXHALL
Model	VECTRA VVT EXCLUSIV
Colour	Silver
Year of manufacture	2008
Top speed	126 mph
0 - 60 mph	10.5 seconds
Gearbox	5 speed Manual

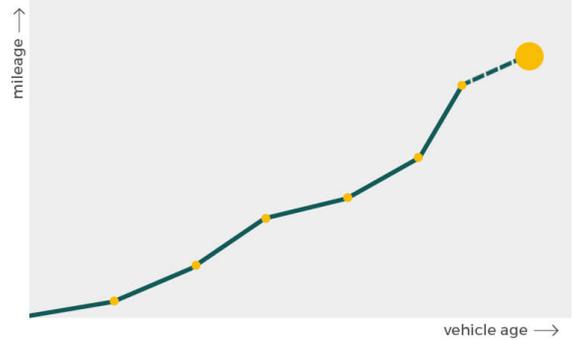
Odometer	In miles
Mileage registrations	18
First mileage registration	2008-05-13
Last registration	2023-11-04
Complete history	See info

Registration #1	2008-05-13	13 mi
Registration #2	2011-05-06	28.301 mi
Registration #3	2012-05-10	33.044 mi
Registration #4	2013-05-03	35.130 mi
Registration #5	2014-05-08	38.455 mi
Registration #6	2015-05-13	40.852 mi
Registration #7	2016-05-05	43.540 mi
Registration #8	2017-05-09	44.646 mi
Registration #9	2018-05-03	46.544 mi
Registration #10	2019-05-03	48.377 mi
Registration #11	2020-05-03	50.210 mi
Registration #12	2021-05-03	52.043 mi
Registration #13	2022-05-03	53.876 mi
Registration #14	2023-05-03	55.709 mi
Registration #15	2023-05-03	57.542 mi
Registration #16	2023-05-03	59.375 mi
Registration #17	2023-05-03	61.208 mi
Registration #18	2023-05-03	63.041 mi
