report date: 2024-03-29

General information

Make	VAUXHALL
Model	VECTRA SRI CDTI 150
Colour	Black
Year of manufacture	2008
Top speed	130 mph
0 - 60 mph	8.6 seconds
Gearbox	6 speed Manual

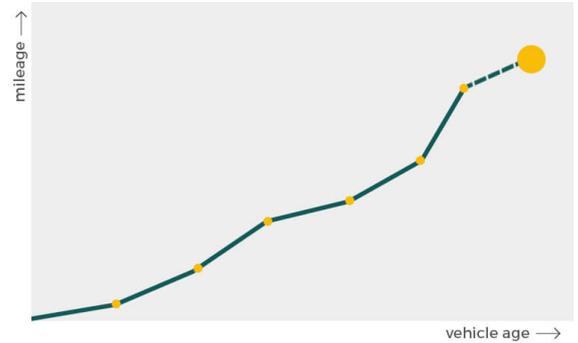
<b>Odometer</b>	In miles
<b>Mileage registrations</b>	15
<b>First mileage registration</b>	2008-03-18
<b>Last registration</b>	2020-10-29
<b>Complete history</b>	<a href="#">See info</a>

<b>Registration #1</b>	2008-03-18	19 mi
<b>Registration #2</b>	2011-04-20	77.167 mi
<b>Registration #3</b>	2012-04-14	90.646 mi
<b>Registration #4</b>	2013-04-09	98.208 mi
<b>Registration #5</b>	2013-04-11	98.288 mi
<b>Registration #6</b>	2014-04-22	103.900 mi
<b>Registration #7</b>	2015-04-23	108.861 mi
<b>Registration #8</b>	2016-04-08	112.321 mi
<b>Registration #9</b>	2017-04-08	112.321 mi
<b>Registration #10</b>	2017-04-08	112.321 mi
<b>Registration #11</b>	2017-04-08	112.321 mi
<b>Registration #12</b>	2017-04-08	112.321 mi
<b>Registration #13</b>	2017-04-08	112.321 mi
<b>Registration #14</b>	2017-04-08	112.321 mi
<b>Registration #15</b>	2017-04-08	112.321 mi
