R7IKRC

report date: 2024-03-29

Make	BMW
Model	Z3 Z3 ROADSTER
Colour	Blue
Year of manufacture	1997
Top speed	128 mph
0 - 60 mph	9.5 seconds
Gearbox	5 speed Manual

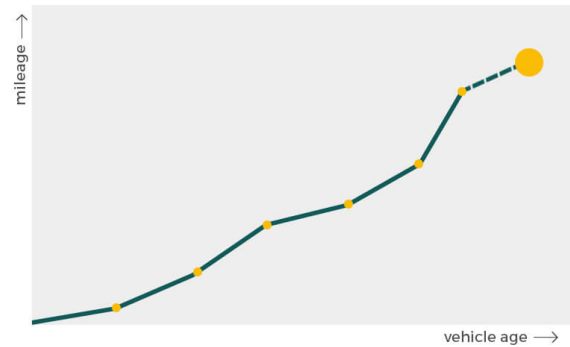
Odometer	In miles
Mileage registrations	30
First mileage registration	1997-08-29
Last registration	2023-09-25
Complete history	See info

Registration #1	1997-08-29	24 mi
Registration #2	2006-07-29	53.579 mi
Registration #3	2007-07-20	58.145 mi
Registration #4	2008-07-29	62.868 mi
Registration #5	2008-08-01	62.888 mi
Registration #6	2009-07-15	67.411 mi
Registration #7	2010-07-30	76.905 mi
Registration #8	2010-07-30	76.905 mi
Registration #9	2011-07-29	83.334 mi
Registration #10	2012-07-13	89.962 mi
Registration #11	2013-07-15	94.198 mi
Registration #12	2013-07-26	94.325 mi
Registration #13	2014-08-28	99.660 mi
Registration #14	2015-07-10	103.321 mi
Registration #15	2015-07-13	103.321 mi
Registration #16	2016-07-29	103.321 mi
Registration #17	2016-07-29	103.321 mi
Registration #18	2016-07-29	103.321 mi
Registration #19	2016-07-29	103.321 mi
Registration #20	2016-07-29	103.321 mi
Registration #21	2016-07-29	103.321 mi
Registration #22	2016-07-29	103.321 mi
Registration #23	2016-07-29	103.321 mi
Registration #24	2016-07-29	103.321 mi
Registration #25	2016-07-29	103.321 mi
