Mercedes-Benz

report date: 2024-03-28

Make	MERCEDES
Model	B-CLASS B150 SE
Colour	Gold
Year of manufacture	2007
Top speed	108 mph
0 - 60 mph	13.2 seconds
Gearbox	5 speed Manual

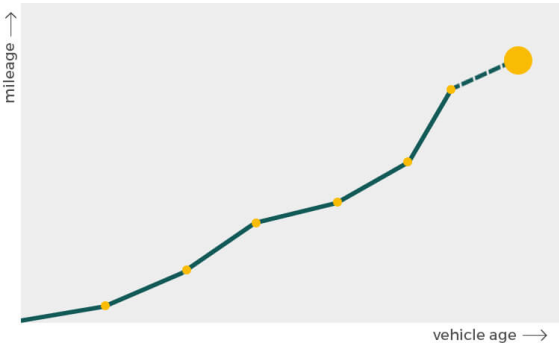
Odometer	In miles
Mileage registrations	27
First mileage registration	2007-03-12
Last registration	2024-04-26
Complete history	<a href="#">See info</a>
