report date: 2024-03-29

Make	NISSAN
Model	PIXO N-TEC
Colour	Red
Year of manufacture	2009
Top speed	96 mph
0 - 60 mph	14.0 seconds
Gearbox	5 speed Manual

MOT history

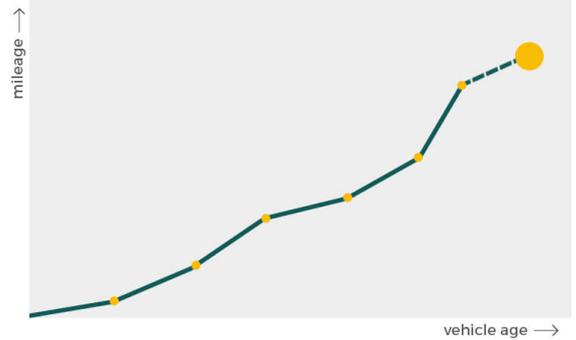
<b>Odometer</b>	In miles
<b>Mileage registrations</b>	17
<b>First mileage registration</b>	2009-09-08
<b>Last registration</b>	2023-11-01
<b>Complete history</b>	<a href="#">See info</a>

<b>Registration #1</b>	2009-09-08	7 mi
<b>Registration #2</b>	2012-08-17	17.064 mi
<b>Registration #3</b>	2013-08-13	20.678 mi
<b>Registration #4</b>	2014-08-11	24.321 mi
<b>Registration #5</b>	2015-02-26	26.979 mi
<b>Registration #6</b>	2016-02-25	29.711 mi
<b>Registration #7</b>	2017-02-22	35.822 mi
<b>Registration #8</b>	2017-02-22	35.822 mi
<b>Registration #9</b>	2018-02-06	39.335 mi
<b>Registration #10</b>	2019-05-29	45.277 mi
<b>Registration #11</b>	2020-05-29	51.219 mi
<b>Registration #12</b>	2021-05-29	57.161 mi
<b>Registration #13</b>	2022-05-29	63.103 mi
<b>Registration #14</b>	2023-05-29	69.045 mi
<b>Registration #15</b>	2023-05-29	69.045 mi
<b>Registration #16</b>	2023-05-29	69.045 mi
<b>Registration #17</b>	2023-11-01	75.000 mi
